Manhole Inspection Summary

Manhole # S19WW_F01MH

Location Address: **1876 MANSION HOUSE DR** Cross Street: **GOLF COURSE**

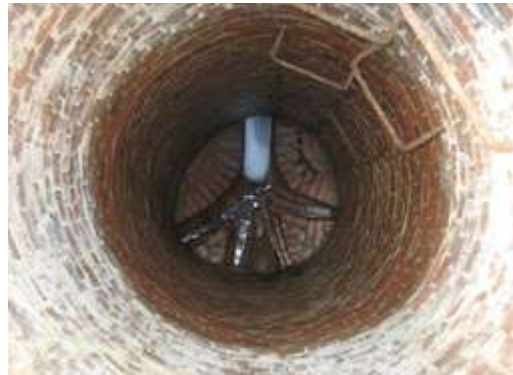
Top View

Bench ☒ Exists Material: **Brick** ☐ Parged ☒ **Debris** (not Condition related)

Steps Count: **9** Missing: **0** ☒ **Corroded**

Corroded steps. Bench debris.

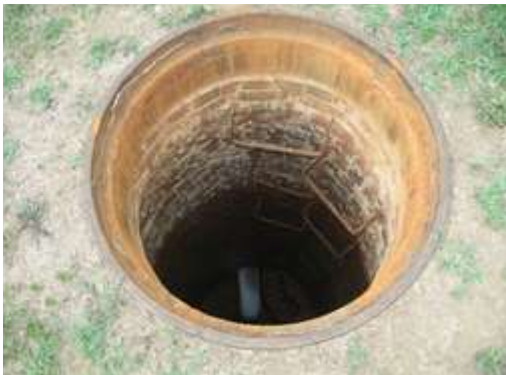
Defect

Frame Offset: **0** (in.) Condition: ☐ Sound ☐ Cracked ☒ **Leaks**

Infiltration: ☐ None ☒ **Joint** ☐ Cracks ☐ Mortar ☐ Roots ☐ Wall

Infiltration: ☐ None ☐ Joint ☐ Cracks ☐ Mortar ☐ Roots ☒ **Wall**

Frame leaks. Adjustment and Barrel infiltration.

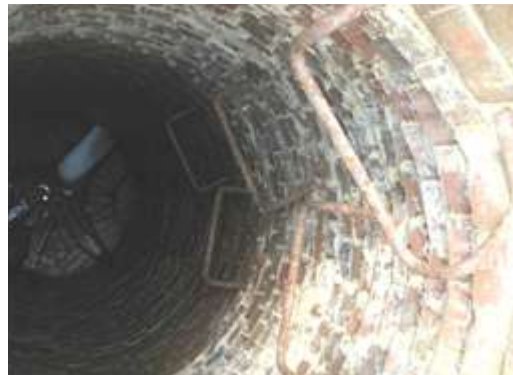
Defect

Frame leaks. Adjustment and Barrel infiltration - other side.

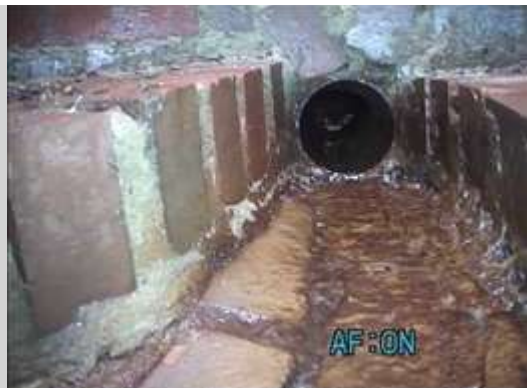
6 in. Circular Gravity Sewer Pipe In @ 3 O'Clock

Infiltration: **Evidence**
